Use of a Biodegradable Magnesium Implant for Osseous Fixation in Four Cases

KEY WORDS: Fracture fixation, Magnesium, Implants

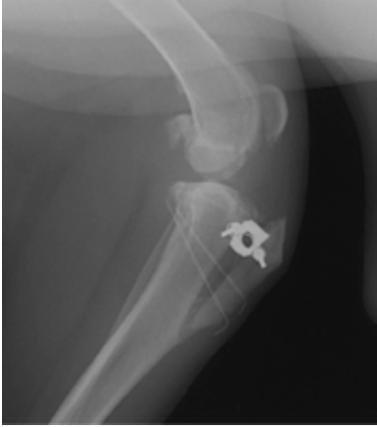
Fig 1. Eight weeks postop TTA (Case 2)

The case details are summarised in Table 1. From the laboratory tests it was known that the mechanical properties of the material were reduced significantly with increasing immersion time. All cases healed uneventfully with no detection of hydrogen gas production. The magnesium pins were still visible although to a much less degree 18 months postoperatively on radiographs (Fig 1, 2, 3, 4, 5).

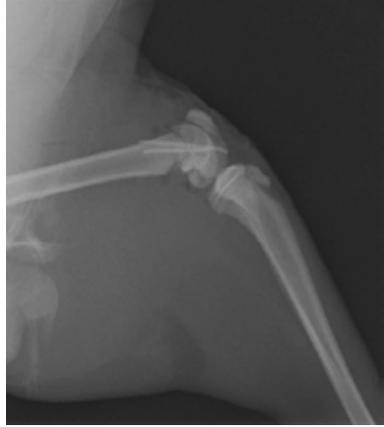
Fig 2. Post op femur fracture (Case 1)

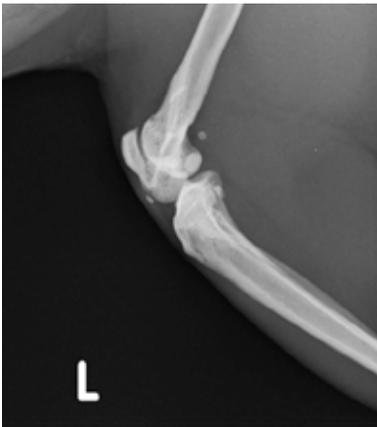
Fig 3. Eighteen months post op (Case 1)

As this is to the author's best knowledge the first research to monitor the degradation of Magnesium beyond 6 months the final radiographic images are intriguing. The implant within the bone has corroded but even at 18 months some of the Magnesium alloy appears to still remain. This may in fact reflect reduced vascularity as the healing process comes to an end. Furthermore some of the outline of the implant may represent a concentration of calcium but this cannot be verified without sampling. Essentially this study has apparently demonstrated that by specially treating the Magnesium implant surface the rate of corrosion is slowed significantly and gas production is not recorded, thus eliminating the original reasons why

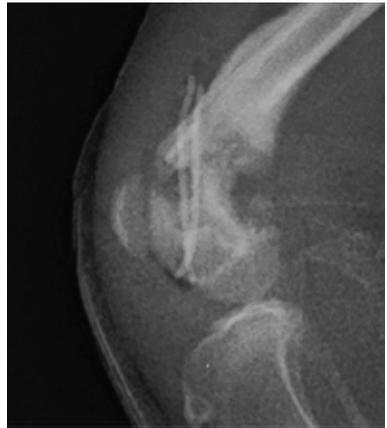
Fig 4. Three weeks postop (Case 3)

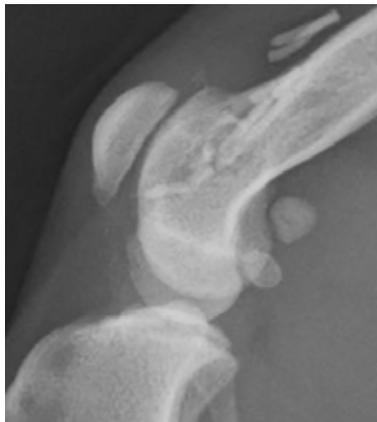
Fig 5. Eighteen months post op (Case 3)
